Volume 41 / Issue 3  
May / June 2018

Advanced detection  
identifies leaks in  
US capital

# Multi-sensory detection system identifies leaks in Washington DC

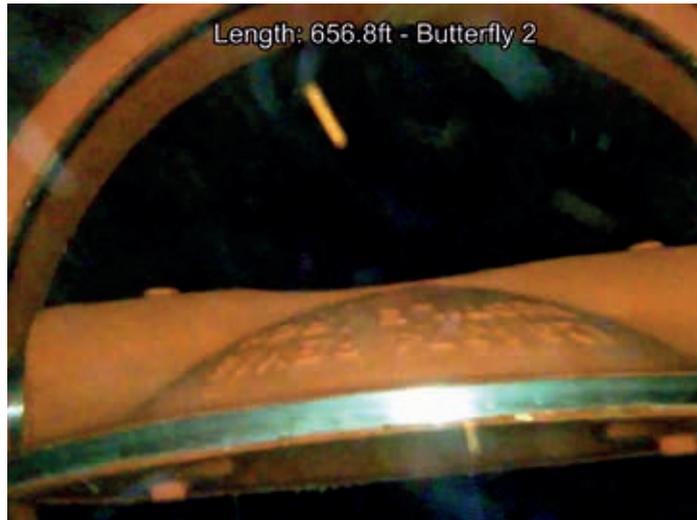
Far left (below): Start access sluice valve installed by DC Water  
 Left: Confirming tracking receiver locates pipe and MTA device  
 Far left (top): The MTA Pipe-Inspector retrieved from the system and net  
 Top right: MTA video capture of 1 of 3 inline horizontal butterfly valves  
 Photos by MTA Messtechnik GmbH
