Detection of Minor Leakage in a Drinking Water Power Plant Pipeline

Project in the South Tyrolean community Mals in Italy

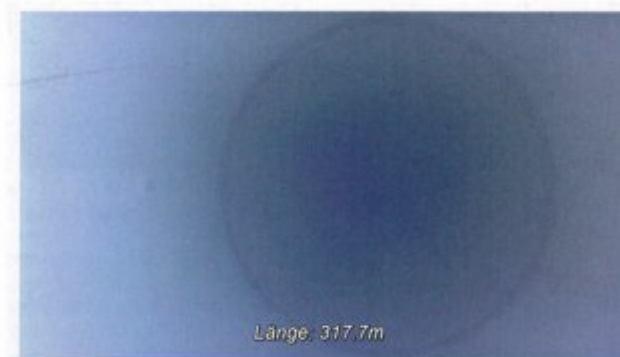
Figure 9: Video image pipe interior

Based on the pressure test results, a water loss of 3.9 l/h has been calculated already in the run-up. This value suggested itself, that imaging techniques wouldn't deliver significant results allowing the optical positioning at such low loss rates. The video data analysis finally confirmed this assumption (Figure 9).

The acoustic analysis identified for instance a clear leak noise at position 317.7 m, although the corresponding

images of the affected area yielded no visible evidence (Figure 9 and 10).

A control inspection of the damaged area using geophone and correlator could not confirm the measurement results delivered by Pipe-Inspector. Once the damage protocol and video data have been sent to the customer, he arranged the excavation at the appropriate position. A subsequent visual pipeline inspection from the outside showed a 100% hit accuracy of the acoustic Pipe-Inspector measurements. The cause of the leak noise was finally elicited as damaged gasket in a sleeve connection. Two other leaks that were identified during the evaluation of the acoustic data, also turned out to be pipe connection problems.

The time and financial cost of the excavation to expose the affected area could be kept to a minimum thanks to the exact lengths indicated by the Pipe-Inspector system. Due to the test results quality, the necessary repair work could take place very quickly, which was the requirement for a repeated pressure test, necessary for the pipeline's commissioning. The total time frame from the arrival to the actual transmission of the evaluated inspection results to the customer was less than three working days.
