World Water

The Sound of Silence

Detecting minor leakage in a water distribution network

A pipe inspection system detects a leak in a drinking water distribution pipeline after a conventional ground microphone method fails to detect leak-related noise. **Sylvia Petschnig** of MTA Messtechnik GmbH explains how the MTA Pipe-Inspector® helped the Dutch water supply utility PWN inspect its underground assets.

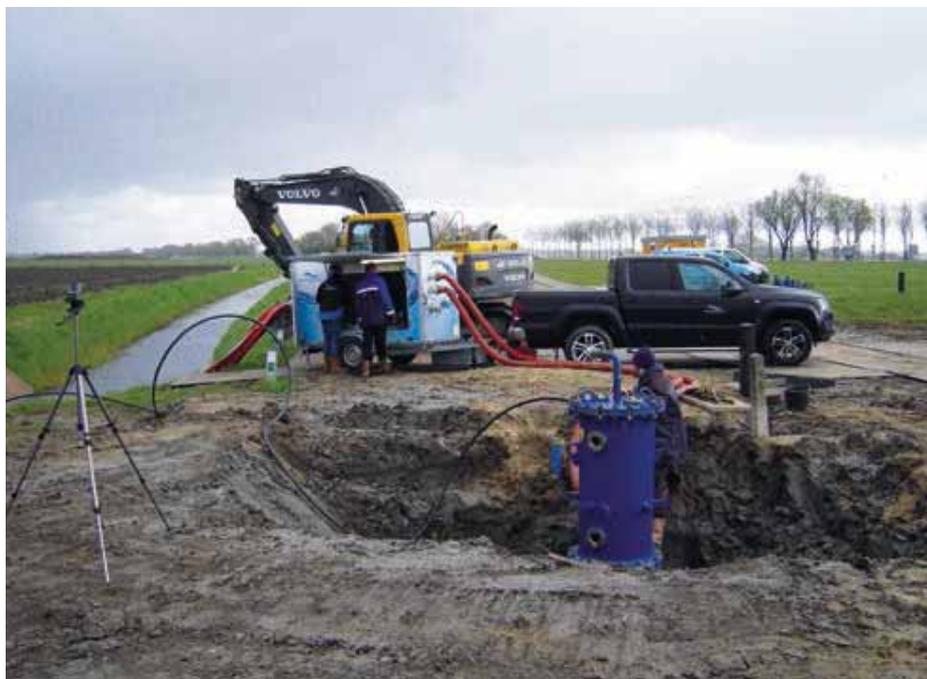
Left: Mobile flow measurement at inspection endpoint

A constant movement speed was adjusted and ensured by using Schmidt Watertechniek mobile flow measurement equipment at the inspection end point. The volume flow rate was recorded throughout the entire inspection time. Based on the continuously recorded pressure curve, four culverts were identified and precisely located.

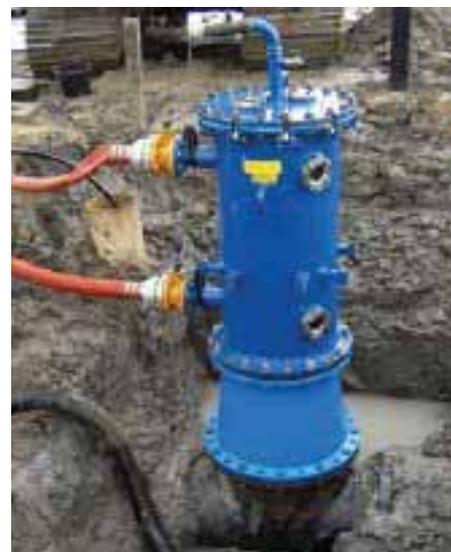
Above: Insertion and retrieval sluce on existing fittings

To start the MTA Pipe-Inspector in pipelines without pig stations, any available fitting with a suitable diameter can be used. Once the necessary framework is in place at the launching point, the entry sluice is installed, and MTA Pipe-Inspector is sent on its way. On the end of the pipeline under inspection, the same conditions are required as at the starting point.

In Schoorldam, Netherlands, MTA deployed a 22-cm (DN 225) Pipe-Inspector, inserted respectively extracted at a service flange exposed by excavation. Since MTA Pipe-Inspector was launched and retrieved via existing fittings, the procedures required only minimal adaption in the form of a sluice mounted on existing flanges.

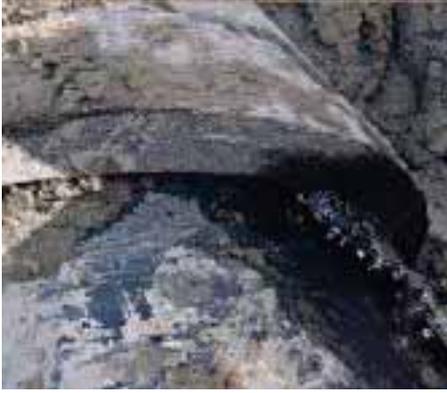
Top right: Leakage after excavation

MTA detected an acoustic anomaly at a position of 1.087 m from the insertion point, indicating a leak that had remained unnoticed by the previous above-ground measurements.

Based on MTA's inspection results, PWN commissioned a construction company to carry out excavation works. The leak was located exactly at the specified position and then repaired. Importantly, PWN gained a reliable data basis for the planned pressure increase as well as a reliable overview about the general pipeline condition.
