SECURE WATER SUPPLY FOR TEXAS' HYDRAULIC FRACTURING

Mag. Sylvia Petschnig, Marketing & Business Development, DI Michael Huainig, Managing Engineer, MTA Messtechnik GmbH, Austria

CALCIUM CARBONATE AFFECTING PIPELINE INTERIOR

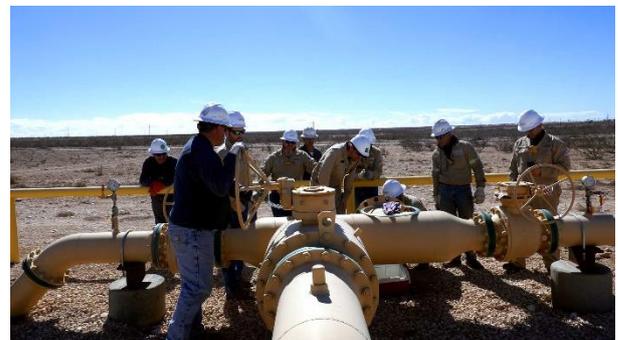
MTA Pipe-Inspector® Inspection, Start Point

Turbidity measurements were taken at the inspection start and end point providing results ranging from 25.4 to 42.6FNU, far above 8FNU, the upper limit to achieve satisfactory video data allowing an optical pipeline condition determination. On that account the inspection’s focus was on the acoustic inspection over a distance of 5,721m (18,770ft).

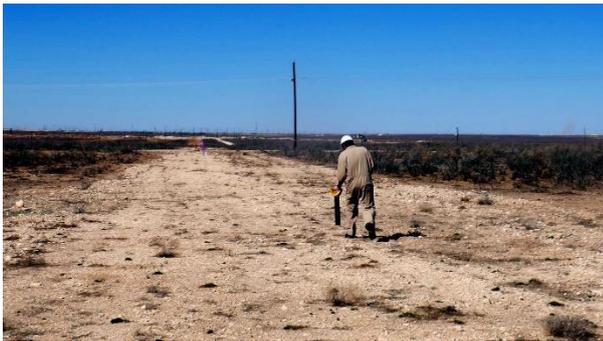
MTA Pipe-Inspector® Inspection, Device Tracking

Tracked above ground to monitor flow velocity and the continuous forward movement inside the pipe. By starting an additional pump increasing the upfront measured flow velocity from 0.4m/s (1.3ft/s) to 0.79m/s (2.6ft/s) it was possible to reduce the calculated duration of the inspection from originally 4 hours down to 2 hours.
