Detection of Minor Leakage in a Drinking Water Power Plant Pipeline

Project in the South Tyrolean community Mals in Italy

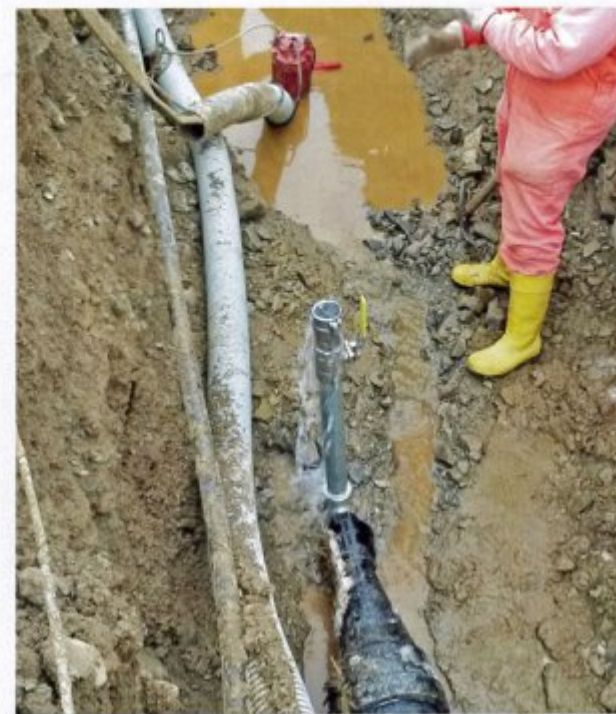
Figure 3: Starting point with water connection point

The Pipe-Inspector device was positioned at a defined starting point in the emptied pipeline and a special locking piece was mounted, furnished with a 90° upstanding water connection point. In a next step, the pipeline was filled with water at the end point of the pipeline section to be inspected and subsequently vented to prevent air pockets in the pipeline, which may reduce the quality of the optical inspection results (Figure 3).

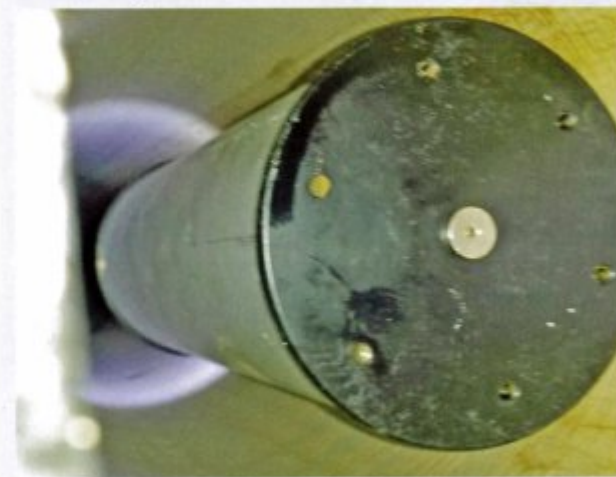
Figure 4: Pipe-Inspector position at starting point

In order to perform the inspection under operating conditions, the pipeline was applied with 30 bar water pressure at the inspection start point, so that the Pipe-Inspector, driven by the media stream, began to move, and the inspection process was started (Figure 4).

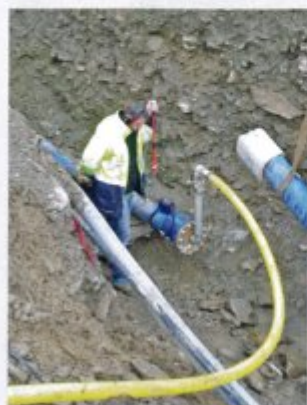
Figure 5: Inspection section end point

The flow rate regulation was achieved by partially opening a valve at the end point of the inspection route (Figure 5).

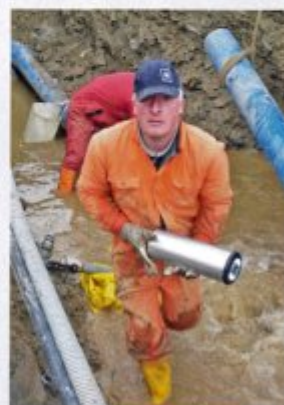
Figure 6: Pipe-Inspector after retrieval

After 28 min the device reached the end point of the 630 m long inspection section and was taken out after emptying the line (Figure 6).
